Case Study

Upgrading a Lime Kiln Chain Section to Reduce Dust Loading and Improve Thermal Efficiency

Odessa Websdale
Peace River Pulp Division
Daishowa Marubeni International Ltd.
Peace River, AB CANADA

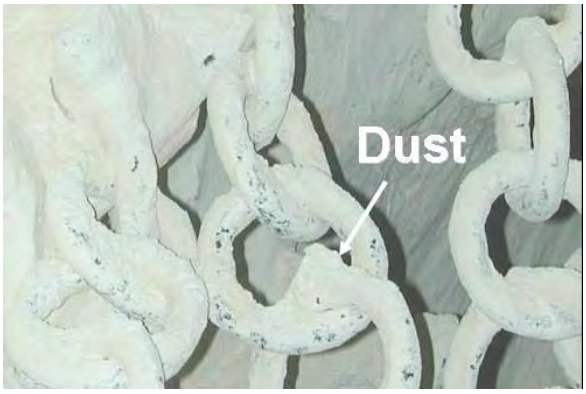
2. the design of round-link chain was such that small "dust scoops" were formed by link connections (Figure 5). The mud collected by these "dust scoops" was carried out of the solids bed and released into the gas steam as the kiln rotated, negatively impacting dust loading.

Figure 5. *"Dust Scoops" formed by round-link chain*

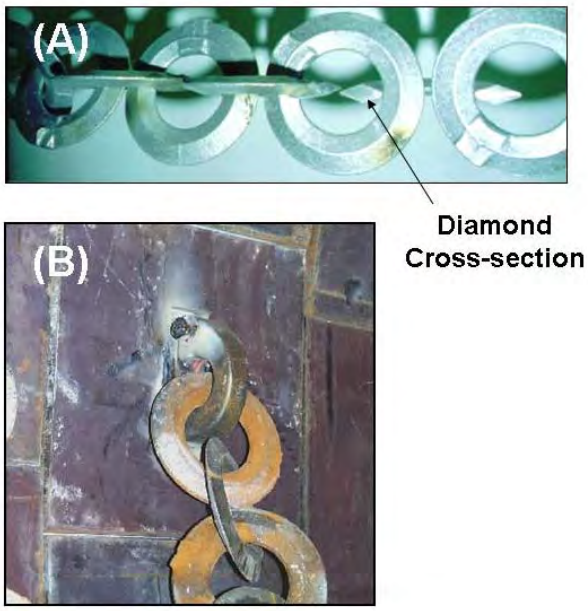
Figure 6. *(A) Jammbco's diamond-link heat exchange chain metal, and (B) Econoliner as insulation medium and attachment point for diamond-link heat exchange chain.*

mud feed screw; 3.5 m of 813 mm tall, angled feed spirals; 5.6 m of carbon-steel round-link chain in the drying zone; 9.2 m of stainless-steel diamond-link heat exchange chain in the preheating zone (Figure 6A); and metal econoliner plates with replaceable link hangar caps and bases (Figure 6B). The complete new chain system was supplied by Jammbco of Barrie, Ontario, Canada.

3. the relatively sharp edge diamond-link heat exchange chain (Figure 6A) was designed to cut through the product layer rather than scooping it up as it is the case for the round-link chain (Figure 5). Furthermore, the number of link connections was halved as a result of the larger surface area inherent to the diamond-link chain style. The weight and metallurgy of the diamond-link chain also made it more resistant to thinning and burn-out.

4. the metal econoliners (Figure 6B) replaced castable refractory as the insulating medium in the chain section. The econoliners did not reduce the inside diameter of the kiln in the chain section as much as castable refractory, and thus reduced gas velocities and dust entrainment in the chain section.

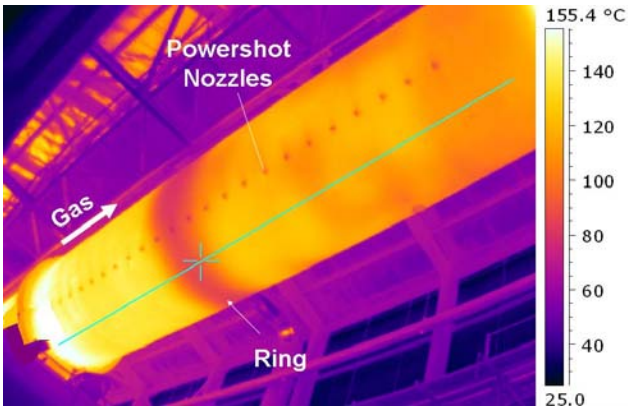
Prior to the chain system upgrade, ring formation downstream of the chain section near the middle of the kiln was a common occurrence (Figures 1 and 13). The build-up was generally difficult to eradicate, and had to be periodically physically removed using the Powershot nozzles. Since the chain system upgrade, the formation of mid-kiln rings seemed to have occurred less frequently. The rings seem to be softer and Powershot operation is not required as often as before the upgrade.

Figure 13. *Thermography scan of kiln hot end shell showing ring formation downstream of chain section and powershot nozzles*
